**Update: 2 Speed Fan and Exhaust Fan Not Detected Alarm**

**Summary:** A False alarm may be generated indicating “2 Speed fan not detected” or “Exhaust fan not detected” in firmware version 1.10.

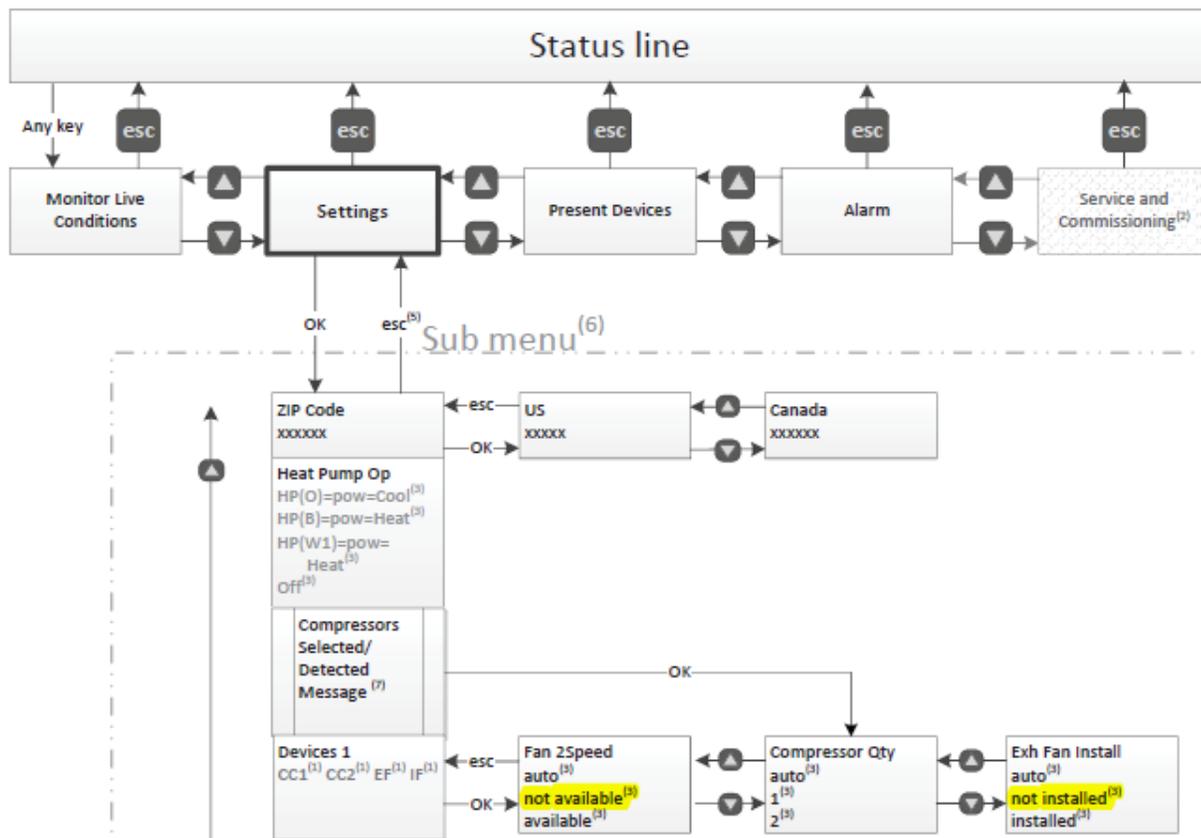
See below settings menu found on [Installation and Operations Manual](#) page 20.

The problem can be resolved by changing these devices from “auto” detected to “not available or “not installed”. Using the buttons on the ECON-ZIP-BASE, select the Settings menu, use the down arrow until menu item “Devices 1” is read. Push “OK” to enter the submenu. Arrow down until “EF” is read. Push OK to enter submenu. Arrow down until “not installed” is read. Push OK to select. Arrow down until “IF” is read. Push “OK” to enter the submenu. Arrow down until “not available” is read. Push OK to select. See settings menu below.
